Manhole Inspection Summary

Manhole # S21MM_020MH

Insp Date: **7/2/07 12:09 PM**

Location Address: **1560 RICHLAND-CLIFTON**

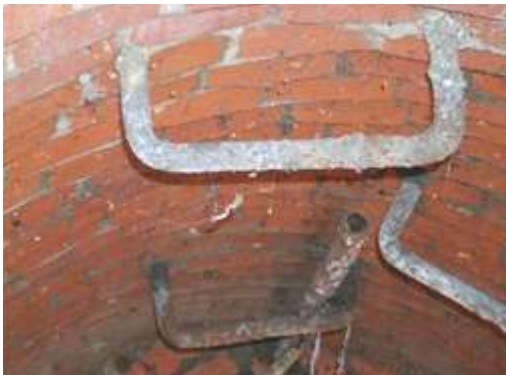
Defect 2

Steps Count: **3** Missing: **0** ☒ **Corroded**

CORRODED STEPS

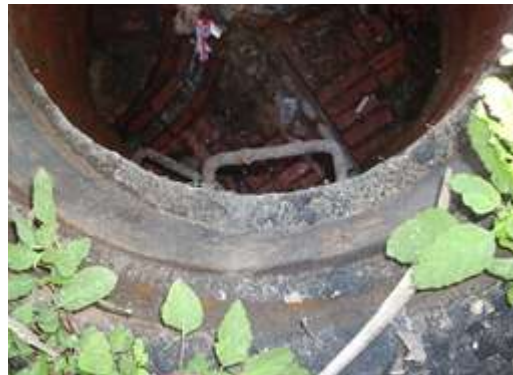
Defect 1

Frame Offset: **2** (in.) Condition: ☒ Sound ☐ Cracked ☐ Leaks

FRAME OFFSET

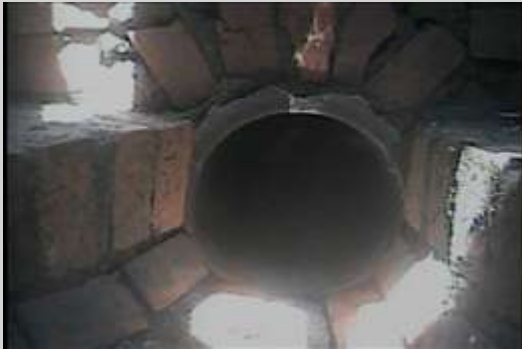
12 O'Clock Outflow

8 in. Circular Gravity Sewer
Pipe Out @ 12 O'Clock

Pipe Height: **8.4** (in.) Rod and Bar (Angled)
Pipe Material: **Clay** ☐ Pipe Lined
Invert Depth: **6.86** (ft.) Flow Characteristics: **Slow**
Deposits: ☒ None ☐ Mud ☐ Sludge ☐ Debris ☐ Grease
Silt Depth: (in.) Deposits Extent:
Infiltration: **None** Pipe Seal Cond: **Sound**

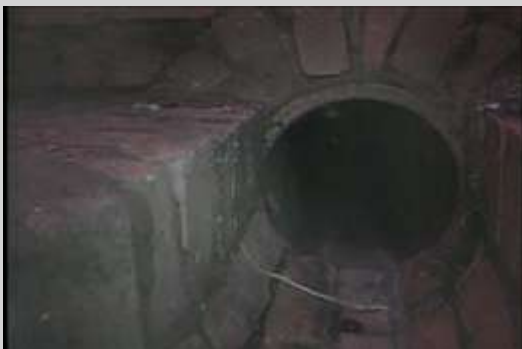
3 O'Clock Inflow

8 in. Circular Gravity Sewer
Pipe In @ 3 O'Clock

Pipe Height: **8.4** (in.) Rod and Bar (Angled)
Pipe Material: **Clay** ☐ Pipe Lined
Invert Depth: **6.75** (ft.) Flow Characteristics: **Slow**
Deposits: ☒ None ☐ Mud ☐ Sludge ☐ Debris ☐ Grease
Silt Depth: (in.) Deposits Extent:
Infiltration: **None** Pipe Seal Cond: **Sound**

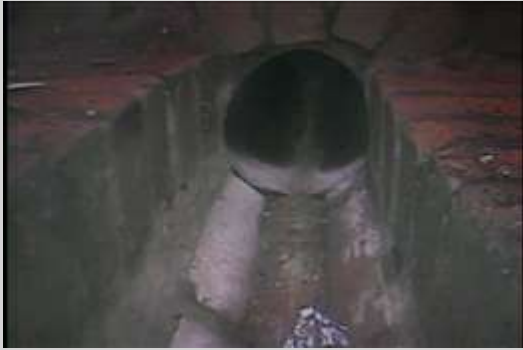
6 O'Clock Inflow

Infiltration: **None**

Pipe Seal Cond: **Sound**

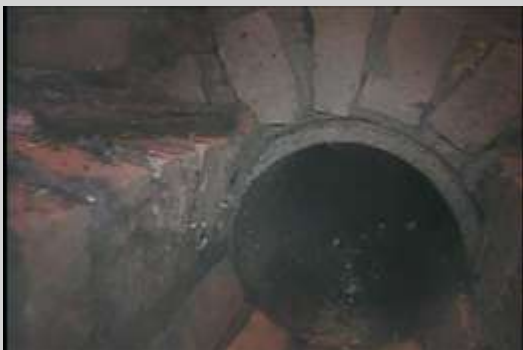
9 O'Clock Inflow

Infiltration: **None**

Pipe Seal Cond: **Sound**
